YOUR ONESURVEY  
**HOME REPORT**

Balmaghie House  
Balmaghie, Castle Douglas  
DG7 2PB

# SINGLE SURVEY

# Single Survey

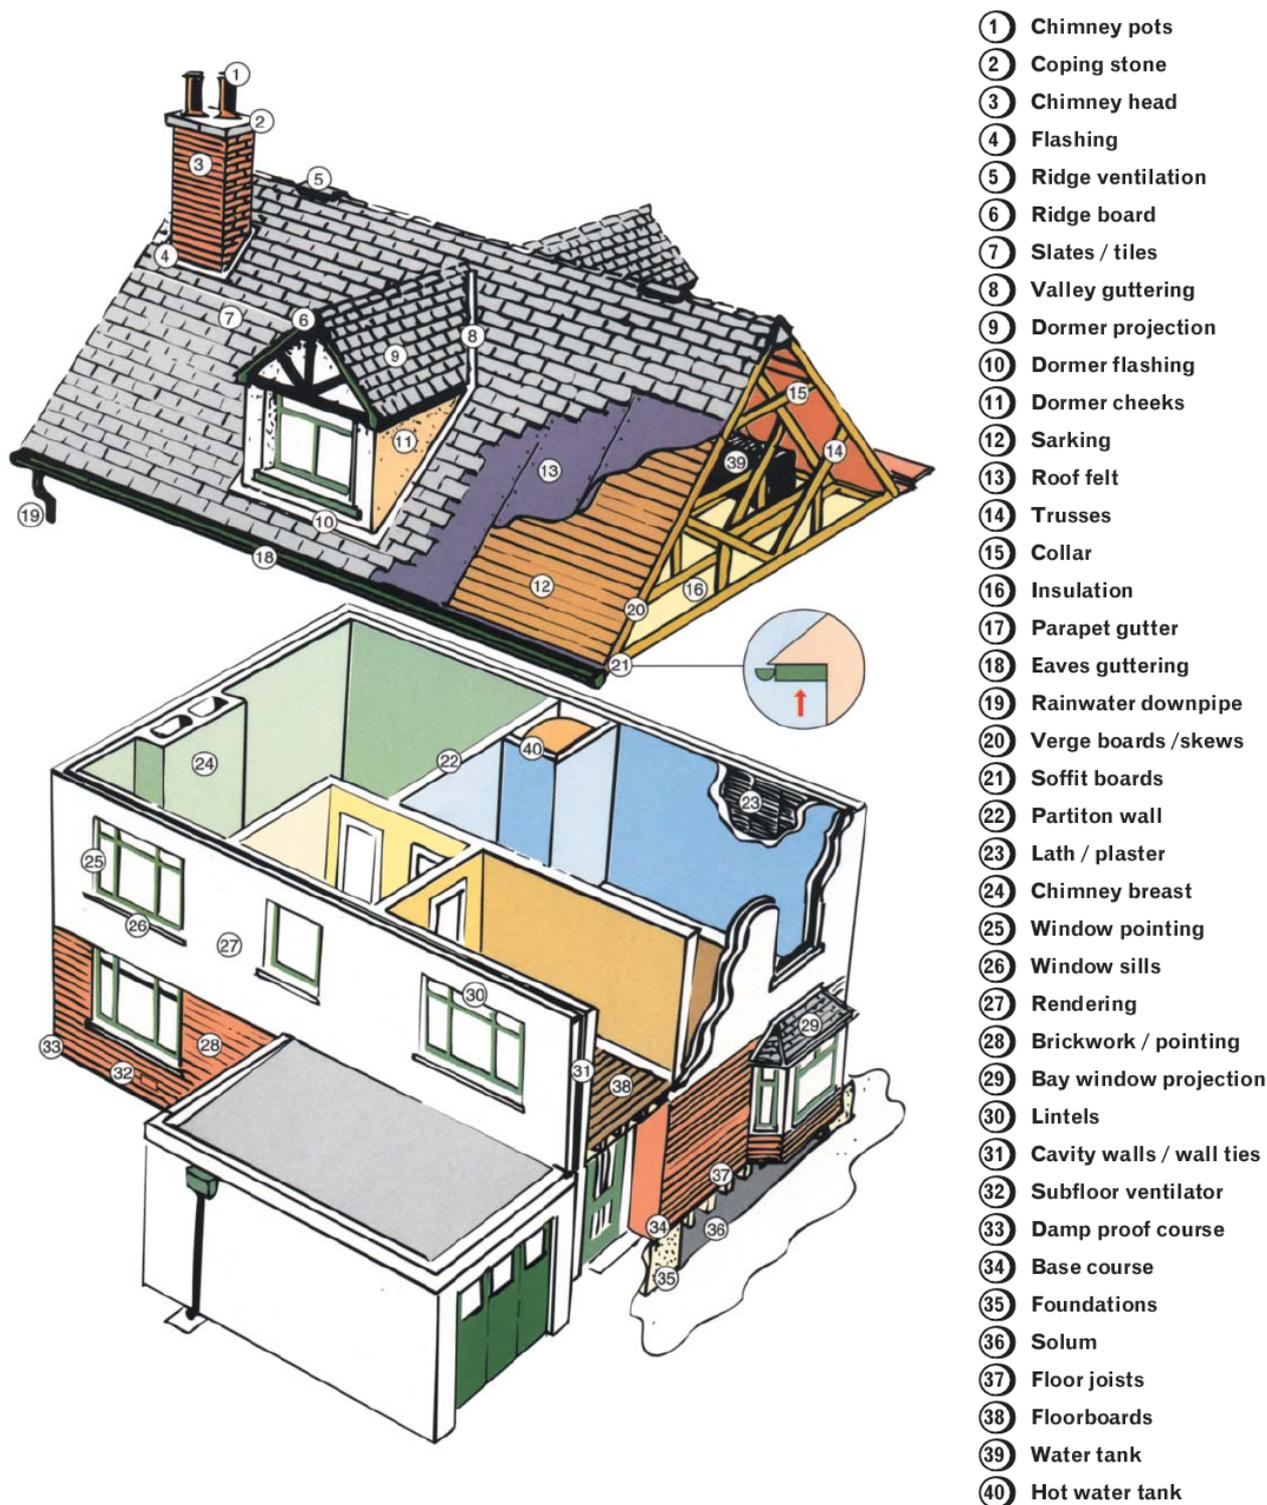
## Sectional Diagram showing elements of a typical house

- ① Chimney pots
- ② Coping stone
- ③ Chimney head
- ④ Flashing
- ⑤ Ridge ventilation
- ⑥ Ridge board
- ⑦ Slates / tiles
- ⑧ Valley guttering
- ⑨ Dormer projection
- ⑩ Dormer flashing
- ⑪ Dormer cheeks
- ⑫ Sarking
- ⑬ Roof felt
- ⑭ Trusses
- ⑮ Collar
- ⑯ Insulation
- ⑰ Parapet gutter
- ⑱ Eaves guttering
- ⑲ Rainwater downpipe
- ⑳ Verge boards /skews
- ㉑ Soffit boards
- ㉒ Partiton wall
- ㉓ Lath / plaster
- ㉔ Chimney breast
- ㉕ Window pointing
- ㉖ Window sills
- ㉗ Rendering
- ㉘ Brickwork / pointing
- ㉙ Bay window projection
- ㉚ Lintels
- ㉛ Cavity walls / wall ties
- ㉜ Subfloor ventilator
- ㉝ Damp proof course
- ㉞ Base course
- ㉟ Foundations
- ㊱ Solum
- ㊲ Floor joists
- ㊳ Floorboards
- ㊴ Water tank
- ㊵ Hot water tank

Reference may be made in this report to some or all of the above component parts of the property. This diagram may assist you in locating and understanding these items.

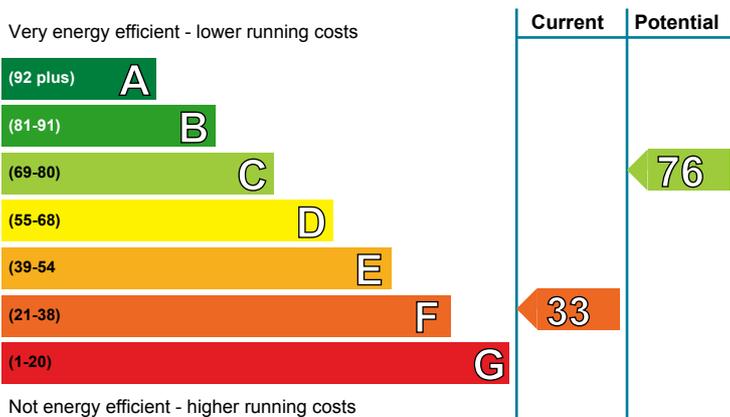
## Energy Efficiency Rating

This graph shows the current efficiency of your home, taking into account both energy efficiency and fuel costs. The higher this rating, the lower your fuel bills are likely to be.

Your current rating is **band F (33)**. The average rating for EPCs in Scotland is **band D (61)**.

The potential rating shows the effect of undertaking all of the improvement measures listed within your recommendations report.

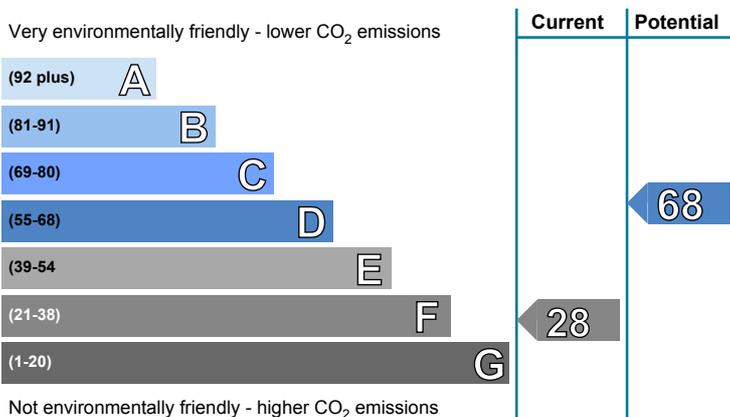
## Environmental Impact (CO<sub>2</sub>) Rating

This graph shows the effect of your home on the environment in terms of carbon dioxide (CO<sub>2</sub>) emissions. The higher the rating, the less impact it has on the environment.
