CASTLEVIEW
2 BORGUE
KIRKCUDBRIGHT
DG6 4UG

Home Report

Scottish Single Survey

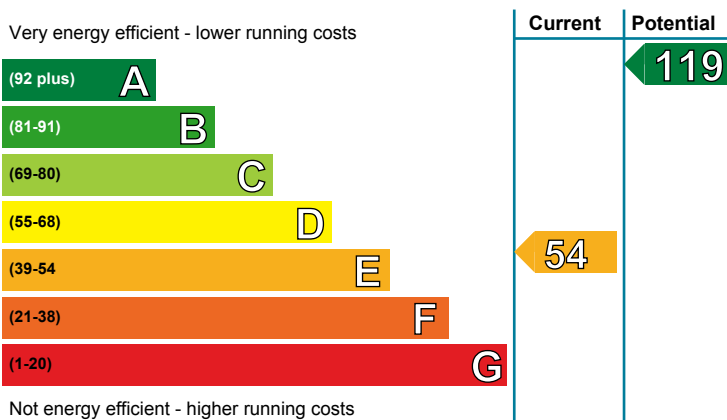
Energy Efficiency Rating

This graph shows the current efficiency of your home, taking into account both energy efficiency and fuel costs. The higher this rating, the lower your fuel bills are likely to be.

Your current rating is **band E (54)**. The average rating for EPCs in Scotland is **band D (61)**.

The potential rating shows the effect of undertaking all of the improvement measures listed within your recommendations report.

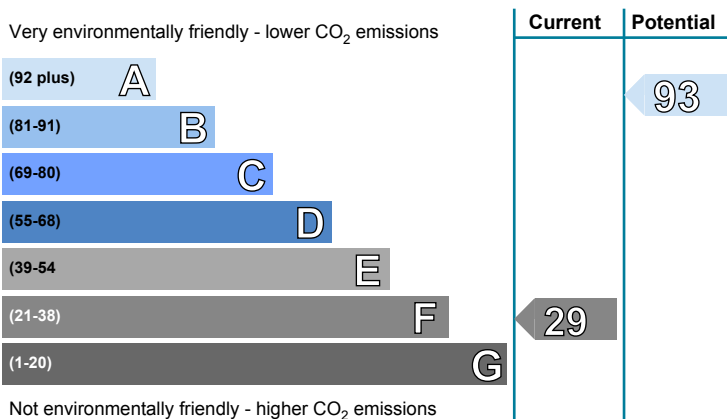
Environmental Impact (CO₂) Rating

This graph shows the effect of your home on the environment in terms of carbon dioxide (CO₂) emissions. The higher the rating, the less impact it has on the environment.

Your current rating is **band F (29)**. The average rating for EPCs in Scotland is **band D (59)**.

The potential rating shows the effect of undertaking all of the improvement measures listed within your recommendations report.
