HILL OF BURNS HILL STREET

Home Report

Energy Performance Certificate

Single Survey

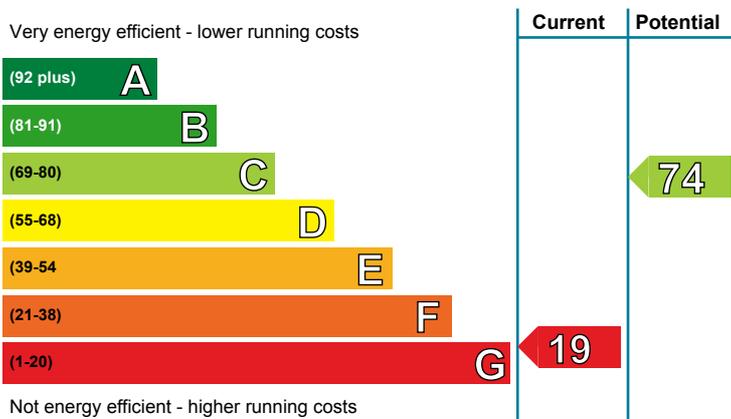
Energy Efficiency Rating

This graph shows the current efficiency of your home, taking into account both energy efficiency and fuel costs. The higher this rating, the lower your fuel bills are likely to be.

Your current rating is **band G (19)**. The average rating for EPCs in Scotland is **band D (61)**.

The potential rating shows the effect of undertaking all of the improvement measures listed within your recommendations report.

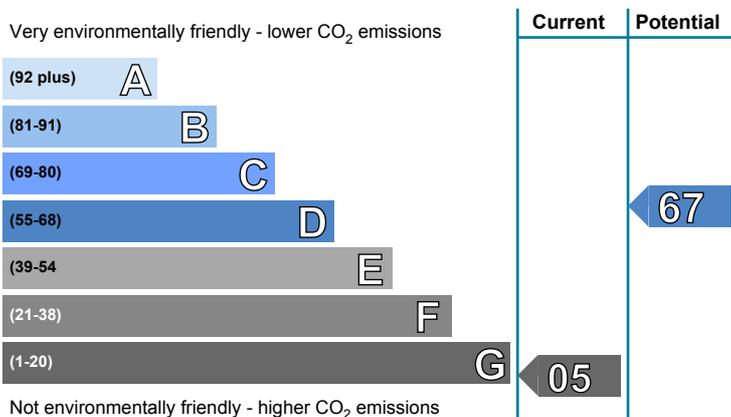
Environmental Impact (CO₂) Rating

This graph shows the effect of your home on the environment in terms of carbon dioxide (CO₂) emissions. The higher the rating, the less impact it has on the environment.

Your current rating is **band G (5)**. The average rating for EPCs in Scotland is **band D (59)**.

The potential rating shows the effect of undertaking all of the improvement measures listed within your recommendations report.
