HIGH DRUMMORE FARM

# Home Report

# Energy Performance Certificate (EPC)

# Scottish Single Survey

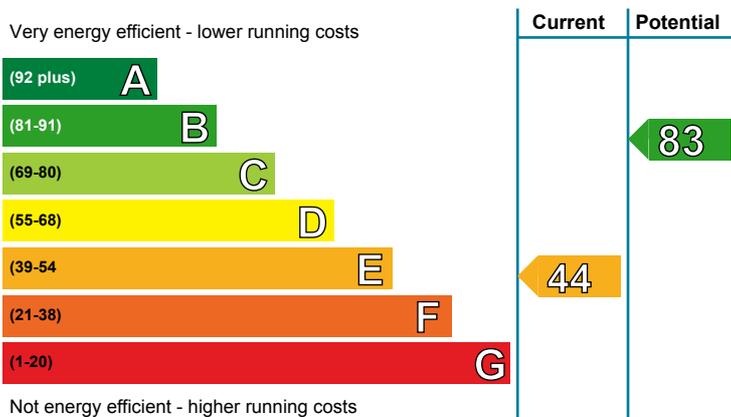
## Energy Efficiency Rating

This graph shows the current efficiency of your home, taking into account both energy efficiency and fuel costs. The higher this rating, the lower your fuel bills are likely to be.

Your current rating is **band E (44)**. The average rating for EPCs in Scotland is **band D (61)**.

The potential rating shows the effect of undertaking all of the improvement measures listed within your recommendations report.

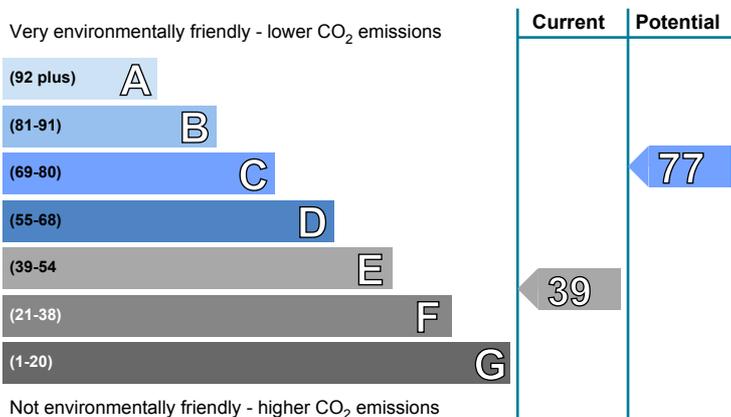
## Environmental Impact (CO<sub>2</sub>) Rating

This graph shows the effect of your home on the environment in terms of carbon dioxide (CO<sub>2</sub>) emissions. The higher the rating, the less impact it has on the environment.

The potential rating shows the effect of undertaking all of the improvement measures listed within your recommendations report.

The average Scottish household produces about 6 tonnes of carbon dioxide every year. Based on this assessment, heating and lighting this home currently produces approximately 16 tonnes of carbon dioxide every year. Adopting recommendations in this report can reduce emissions and protect the environment. If you were to install all of these recommendations this could reduce emissions by 9.6 tonnes per year. You could reduce emissions even more by switching to renewable energy sources.
