YOUR ONESURVEY  
**HOME REPORT**

Little Knox  
Castle Douglas  
DG7 1NR

# SINGLE SURVEY

# Single Survey

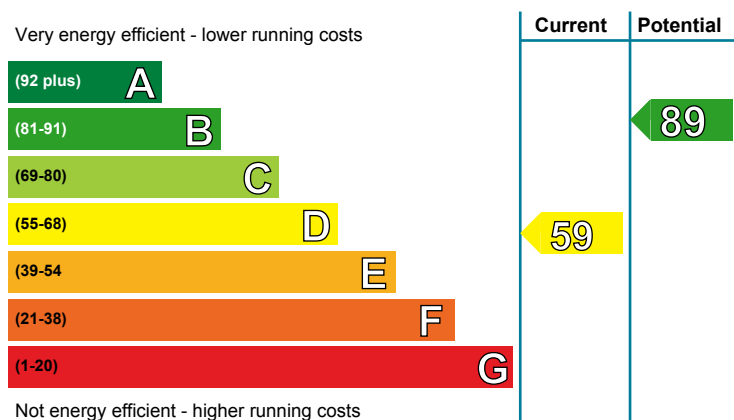
## Energy Efficiency Rating

This graph shows the current efficiency of your home, taking into account both energy efficiency and fuel costs. The higher this rating, the lower your fuel bills are likely to be.

The potential rating shows the effect of undertaking all of the improvement measures listed within your recommendations report.

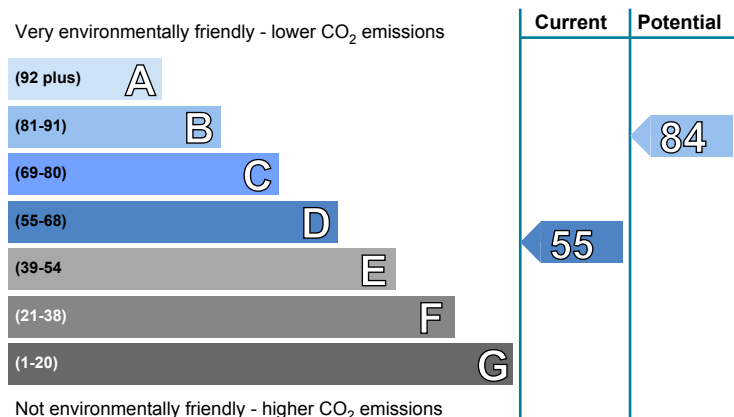
## Environmental Impact (CO<sub>2</sub>) Rating

This graph shows the effect of your home on the environment in terms of carbon dioxide (CO<sub>2</sub>) emissions. The higher the rating, the less impact it has on the environment.
