WINDYRIDGE
AUCHNOTTEROCH
LESWALT
STRANRAER
DG9 0LX

Home Report

Energy Performance Certificate (EPC)

Scottish Single Survey

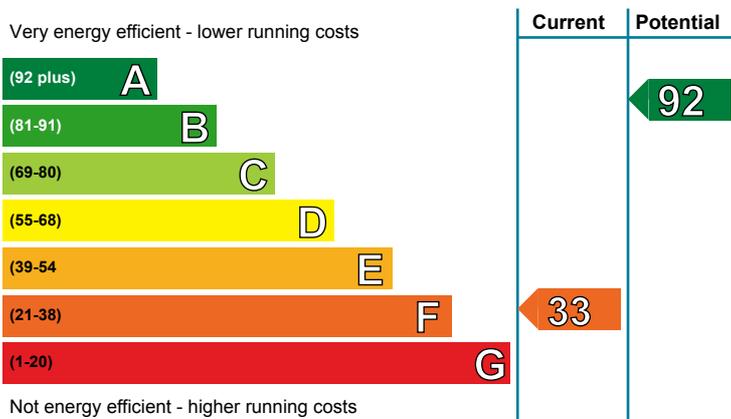
Energy Efficiency Rating

This graph shows the current efficiency of your home, taking into account both energy efficiency and fuel costs. The higher this rating, the lower your fuel bills are likely to be.

Your current rating is **band F (33)**. The average rating for EPCs in Scotland is **band D (61)**.

The potential rating shows the effect of undertaking all of the improvement measures listed within your recommendations report.

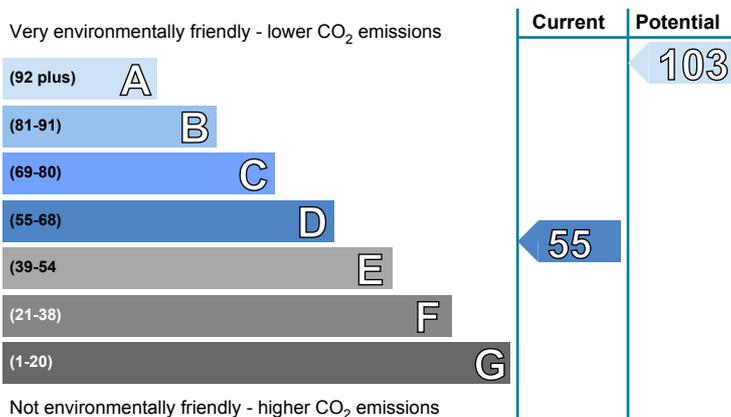
Environmental Impact (CO₂) Rating

This graph shows the effect of your home on the environment in terms of carbon dioxide (CO₂) emissions. The higher the rating, the less impact it has on the environment.

Your current rating is **band D (55)**. The average rating for EPCs in Scotland is **band D (59)**.

The potential rating shows the effect of undertaking all of the improvement measures listed within your recommendations report.
