Home Report

Scottish Single Survey

Property address	47 Ernespie Road CASTLE DOUGLAS DG7 1LD
-------------------------	---

Prepared by	Shepherd Chartered Surveyors
--------------------	------------------------------

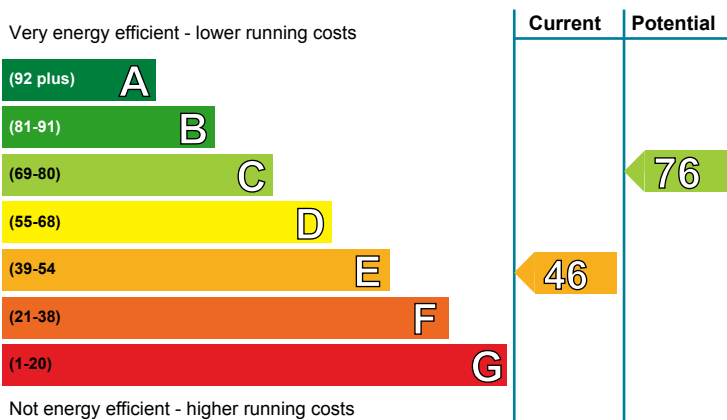
Energy Efficiency Rating

This graph shows the current efficiency of your home, taking into account both energy efficiency and fuel costs. The higher this rating, the lower your fuel bills are likely to be.

Your current rating is **band E (46)**. The average rating for EPCs in Scotland is **band D (61)**.

The potential rating shows the effect of undertaking all of the improvement measures listed within your recommendations report.
