# Home Report

# Scottish Single Survey

<b>Property address</b>	Torkatrine Bungalow Dalbeattie DG5 4NQ
-------------------------	--

<b>Prepared by</b>	Shepherd Chartered Surveyors
--------------------	------------------------------

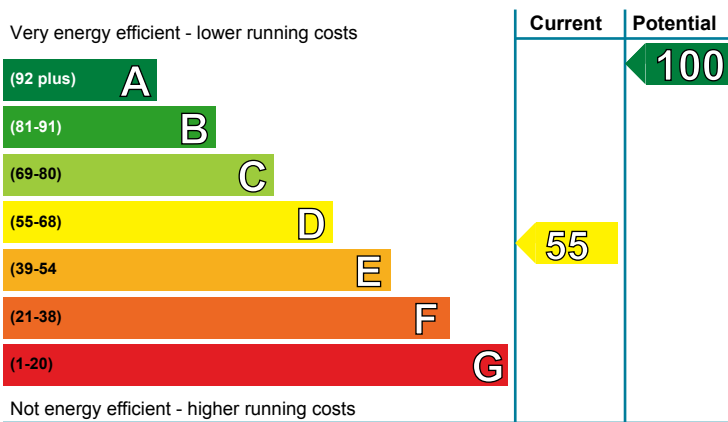
### Energy Efficiency Rating

This graph shows the current efficiency of your home, taking into account both energy efficiency and fuel costs. The higher this rating, the lower your fuel bills are likely to be.

Your current rating is **band D (55)**. The average rating for EPCs in Scotland is **band D (61)**.

The potential rating shows the effect of undertaking all of the improvement measures listed within your recommendations report.

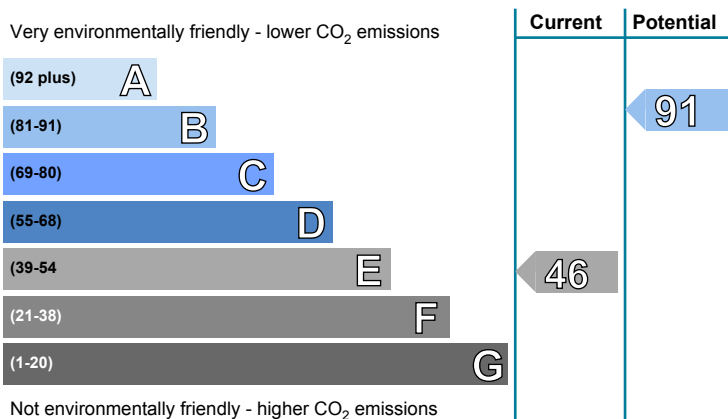
### Environmental Impact (CO<sub>2</sub>) Rating

This graph shows the effect of your home on the environment in terms of carbon dioxide (CO<sub>2</sub>) emissions. The higher the rating, the less impact it has on the environment.
