YOUR ONESURVEY
HOME REPORT

Yettan Cottage
Palnackie, Castle Douglas
DG7 1PG

SINGLE SURVEY

A report on the condition of the property, with categories being rated from 1 to 3.

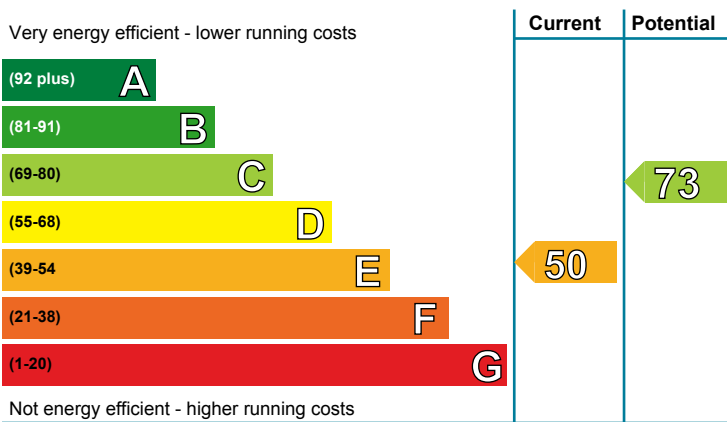
Energy Efficiency Rating

This graph shows the current efficiency of your home, taking into account both energy efficiency and fuel costs. The higher this rating, the lower your fuel bills are likely to be.

Your current rating is **band E (50)**. The average rating for EPCs in Scotland is **band D (61)**.

The potential rating shows the effect of undertaking all of the improvement measures listed within your recommendations report.

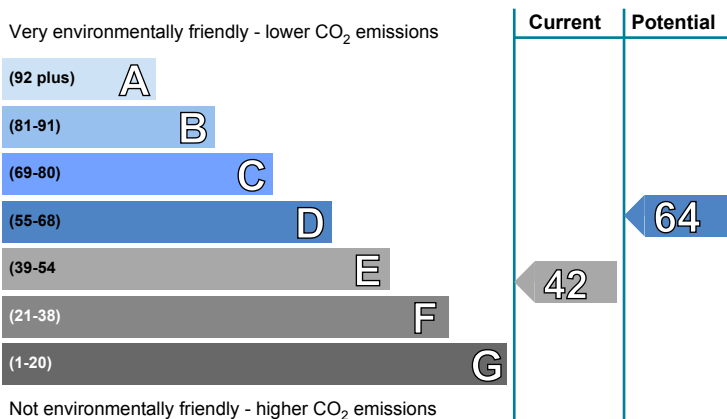
Environmental Impact (CO₂) Rating

This graph shows the effect of your home on the environment in terms of carbon dioxide (CO₂) emissions. The higher the rating, the less impact it has on the environment.
