Home Report

Single Survey

Property address	1 Cairnsmore Road Castle Douglas DG7 1BN
Customer	Mrs Kirsti Ede
Customer address	1 Cairnsmore Road Castle Douglas DG7 1BN
Prepared by	Shepherd Chartered Surveyors
Date of inspection	21/02/2024

Energy Performance Certificate

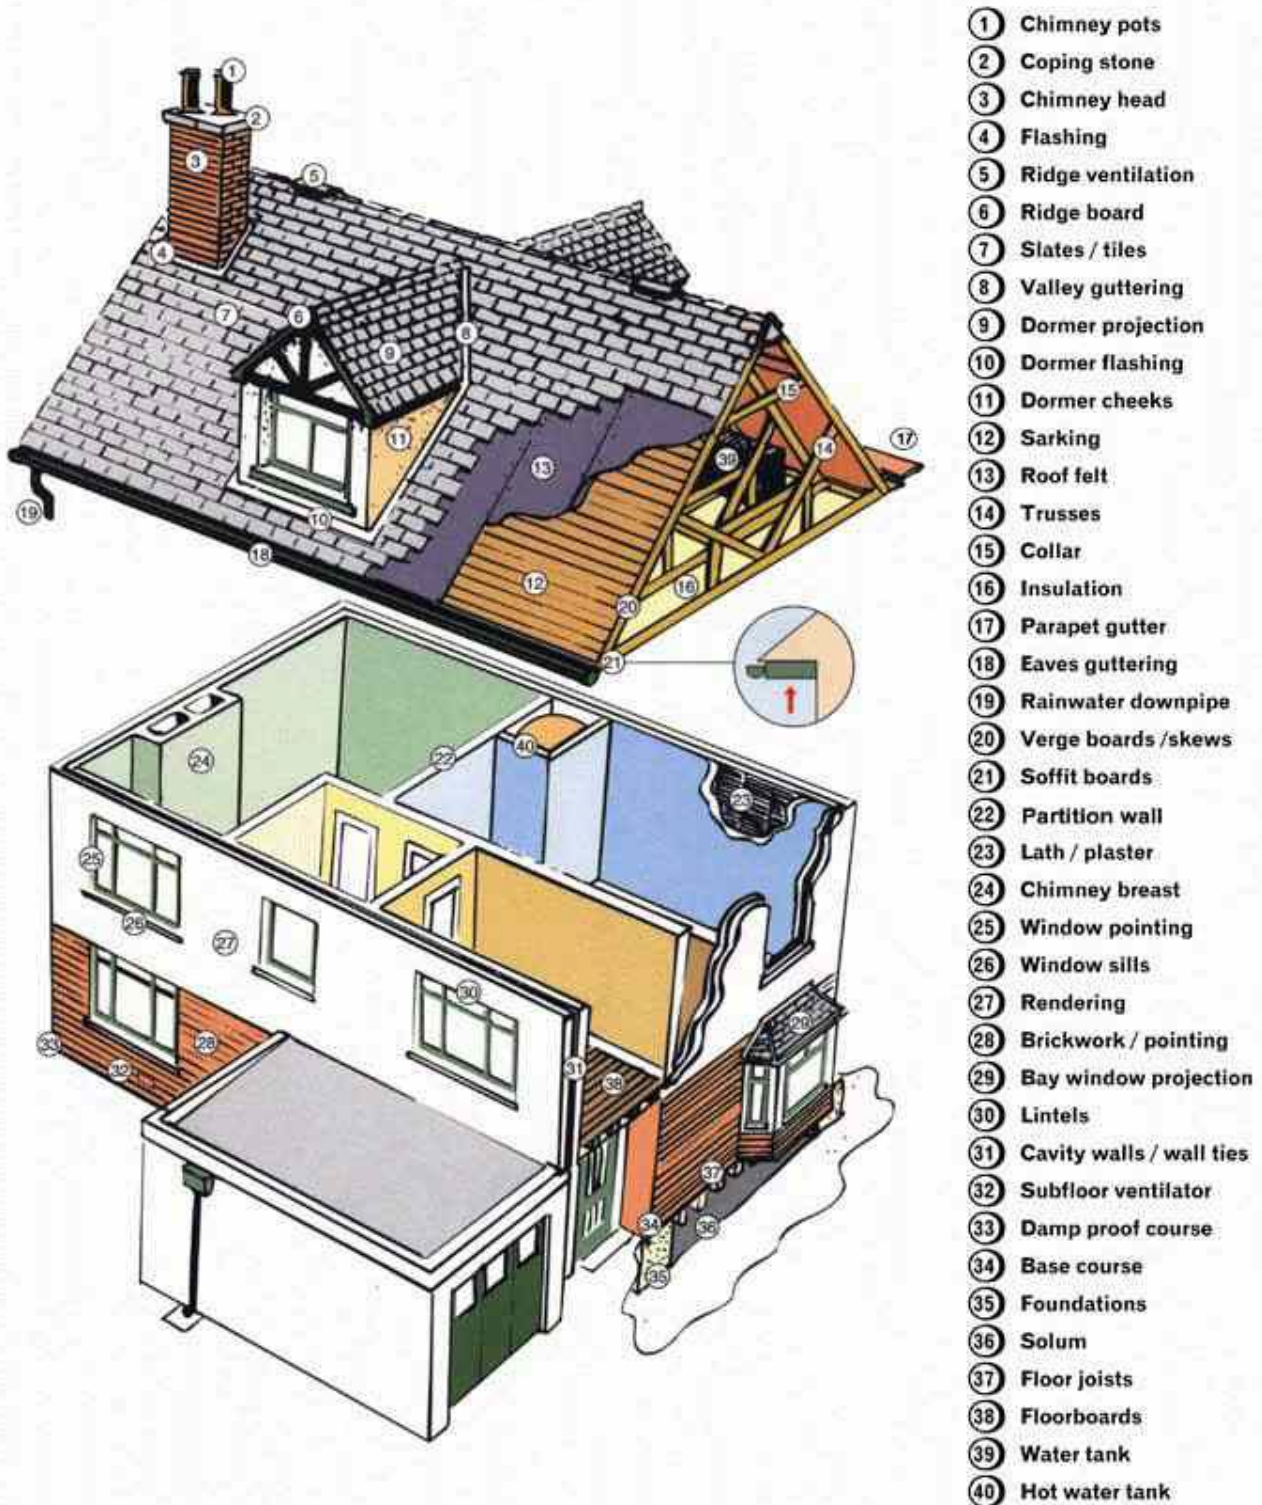
Sectional Diagram showing elements of a typical house

Reference may be made in this report to some or all of the above component parts of the property. This diagram may assist you in locating and understanding these items.
