# Home Report

Raeburn Cottage  
Castle Douglas DG7 1NJ

Date of Valuation: 26/01/2026

# Single Survey

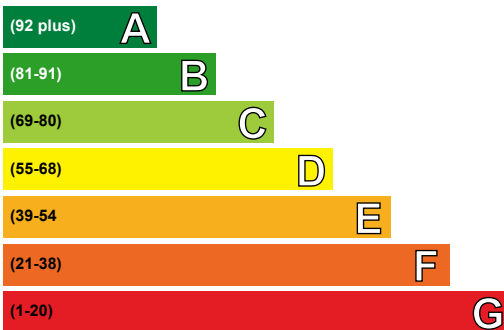
Very energy efficient - lower running costs

Not energy efficient - higher running costs

The potential rating shows the effect of undertaking all of the improvement measures listed within your recommendations report.

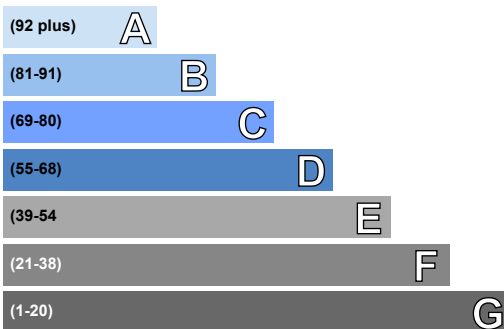
Very environmentally friendly - lower CO<sub>2</sub> emissions

Not environmentally friendly - higher CO<sub>2</sub> emissions
