Home Report

Scottish Single Survey

| Property address | Loch Rannoch Kirkgunzeon Dumfries DG2 8JN |
| Prepared by | Shepherd Chartered Surveyors |

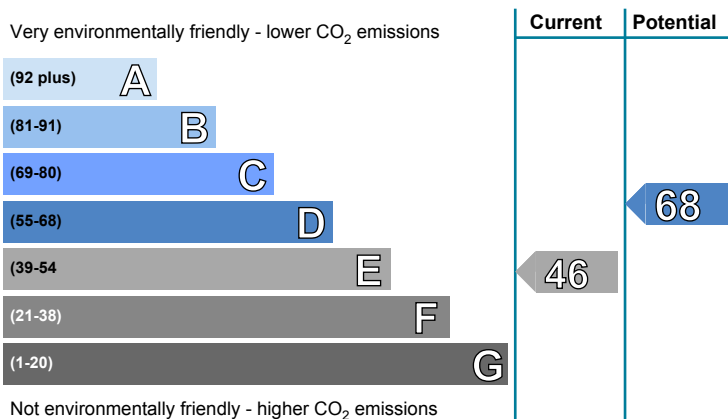
Environmental Impact (CO₂) Rating

This graph shows the effect of your home on the environment in terms of carbon dioxide (CO₂) emissions. The higher the rating, the less impact it has on the environment.
