Home Report

Scottish Single Survey

Property address	Ingleston Farmhouse Twynholm Kirkcudbright DG6 4SE
-------------------------	---

Prepared by	Shepherd Chartered Surveyors
--------------------	------------------------------

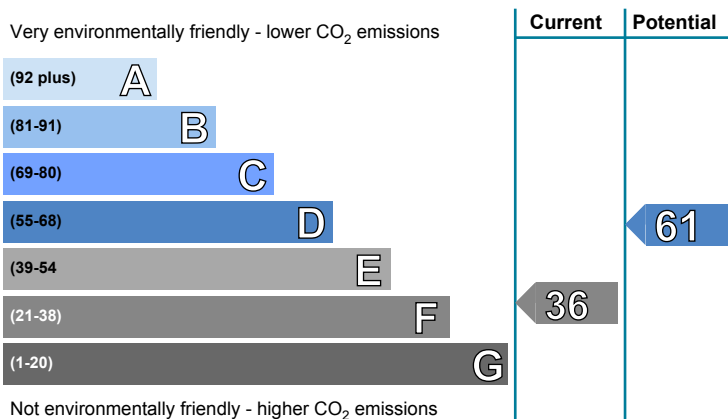
Environmental Impact (CO₂) Rating

This graph shows the effect of your home on the environment in terms of carbon dioxide (CO₂) emissions. The higher the rating, the less impact it has on the environment.

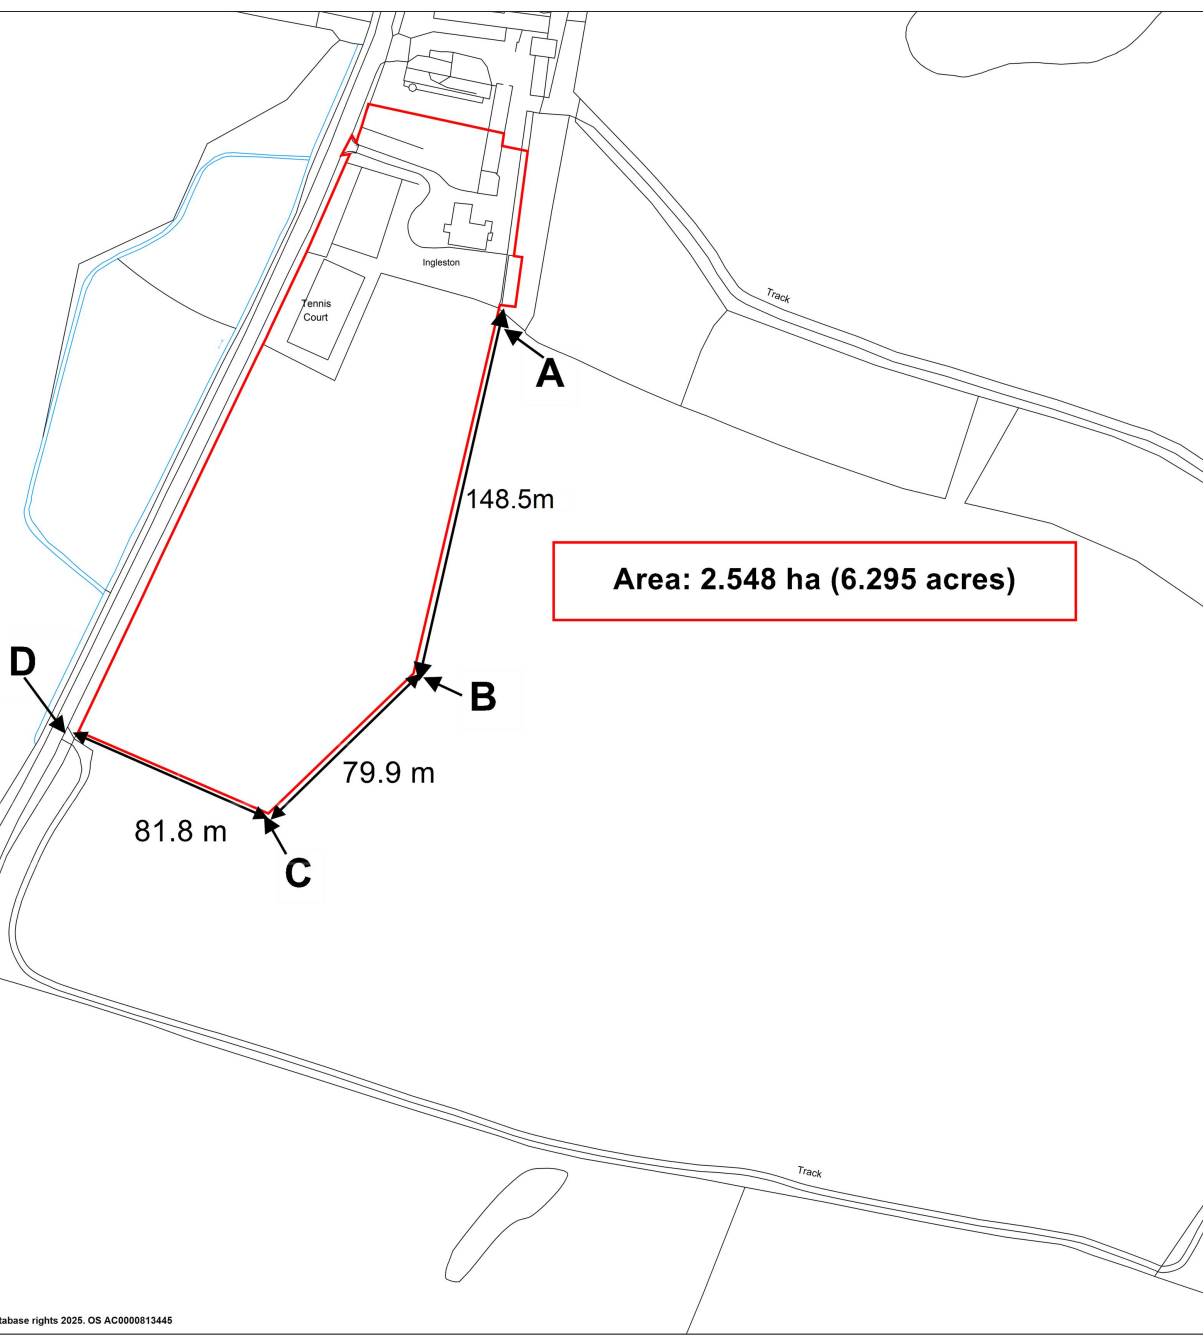
Area: 2.548 ha (6.295 acres)
