Home Report

Single Survey

Property address	Garrochar Farm House Creetown Newton Stewart DG8 7EU
Customer	Mr Edward Downs
Customer address	Garrochar Farm House Creetown Newton Stewart DG8 7EU
Prepared by	Shepherd Chartered Surveyors
Date of inspection	24/11/2025

Energy Performance Certificate (EPC)

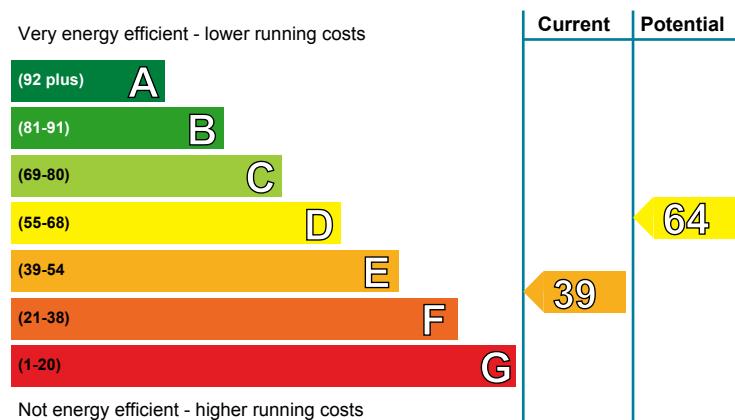
Energy Efficiency Rating

This graph shows the current efficiency of your home, taking into account both energy efficiency and fuel costs. The higher this rating, the lower your fuel bills are likely to be.

Your current rating is **band E (39)**. The average rating for EPCs in Scotland is **band D (61)**.

The potential rating shows the effect of undertaking all of the improvement measures listed within your recommendations report.

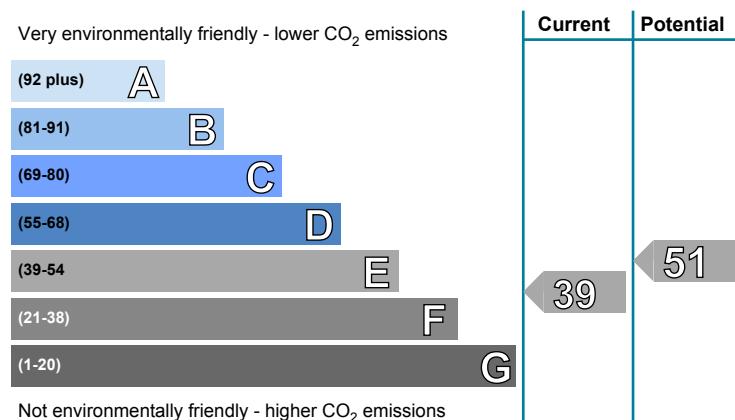
Environmental Impact (CO₂) Rating

This graph shows the effect of your home on the environment in terms of carbon dioxide (CO₂) emissions. The higher the rating, the less impact it has on the environment.
