# Home Report

Woodlands  
Castle Douglas DG7 2LL

# Single Survey

| <b>Description</b> | The subjects comprise a detached two story house. |

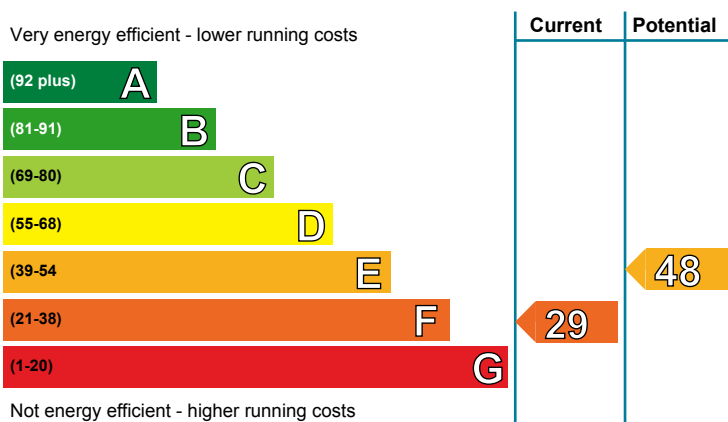
## Energy Efficiency Rating

This graph shows the current efficiency of your home, taking into account both energy efficiency and fuel costs. The higher this rating, the lower your fuel bills are likely to be.

The potential rating shows the effect of undertaking all of the improvement measures listed within your recommendations report.

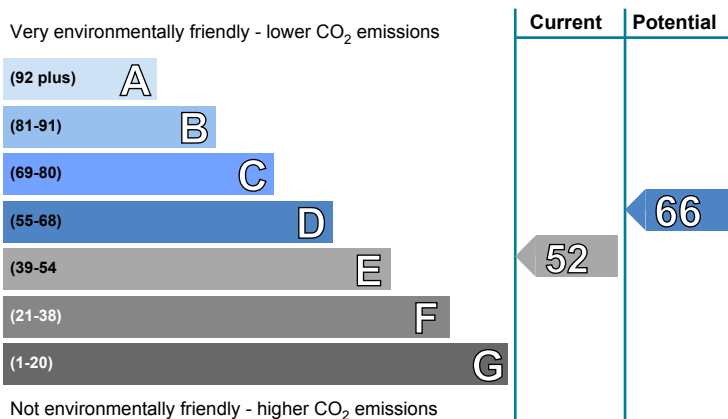
## Environmental Impact (CO<sub>2</sub>) Rating

This graph shows the effect of your home on the environment in terms of carbon dioxide (CO<sub>2</sub>) emissions. The higher the rating, the less impact it has on the environment.
