# Home Report

# Scottish Single Survey

<b>Property address</b>	Cairngill Cottage Sandyhills Dalbeattie DG5 4NZ
<b>Customer</b>	Mr & Mrs David Athron
<b>Customer address</b>	Cairngill Cottage Sandyhills Dalbeattie DG5 4NZ
<b>Prepared by</b>	Shepherd Chartered Surveyors
<b>Date of inspection</b>	14/04/2026

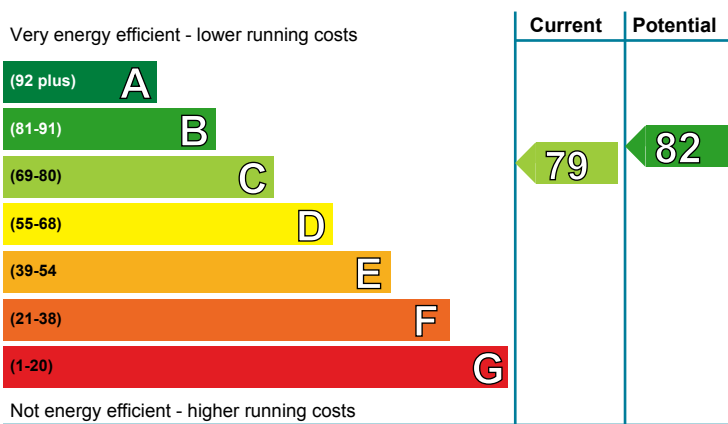
## Energy Efficiency Rating

This graph shows the current efficiency of your home, taking into account both energy efficiency and fuel costs. The higher this rating, the lower your fuel bills are likely to be.

Your current rating is **band C (79)**. The average rating for EPCs in Scotland is **band D (61)**.

The potential rating shows the effect of undertaking all of the improvement measures listed within your recommendations report.
