# Home Report

# Scottish Single Survey

# Single Survey

<b>Property address</b>	Carseholm Culdoach Road Tongland Kirkcudbright DG6 4LU
-------------------------	--

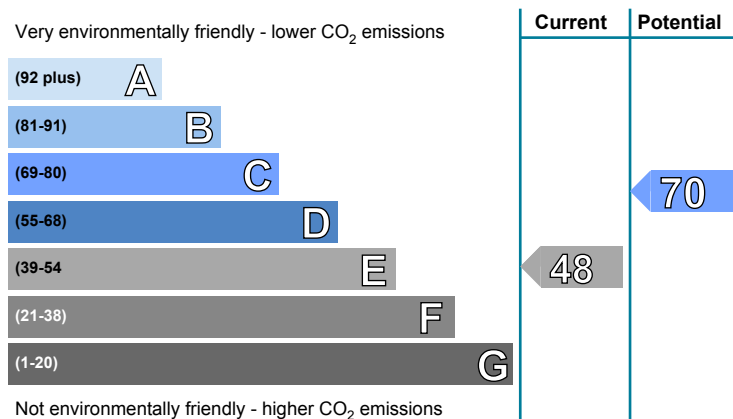
## Environmental Impact (CO<sub>2</sub>) Rating

This graph shows the effect of your home on the environment in terms of carbon dioxide (CO<sub>2</sub>) emissions. The higher the rating, the less impact it has on the environment.
