Home Report

Scottish Single Survey

Single Survey

| Property address | Myrtle Cottage High Road Hightae Lockerbie DG11 1JS |

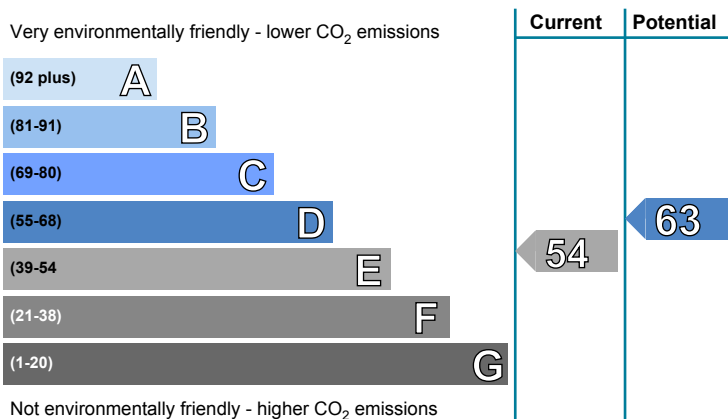
Environmental Impact (CO₂) Rating

This graph shows the effect of your home on the environment in terms of carbon dioxide (CO₂) emissions. The higher the rating, the less impact it has on the environment.
