Ardwall Mains Farmhouse,  
New Abbey,  
Dumfries,  
DG2 8DH

# Home Report

# Single Survey

## Survey Report on:

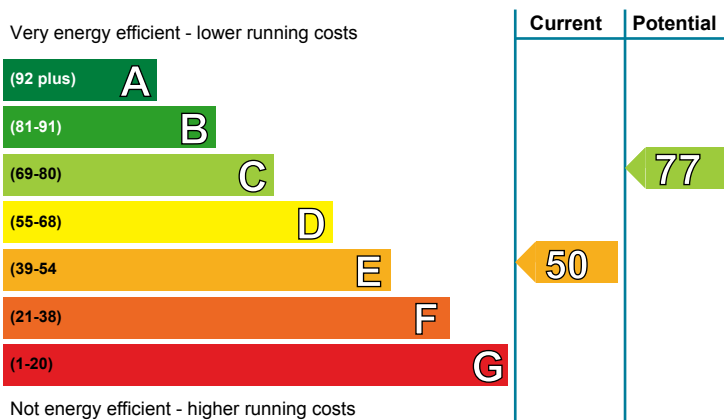
## Energy Efficiency Rating

This graph shows the current efficiency of your home, taking into account both energy efficiency and fuel costs. The higher this rating, the lower your fuel bills are likely to be.

The potential rating shows the effect of undertaking all of the improvement measures listed within your recommendations report.

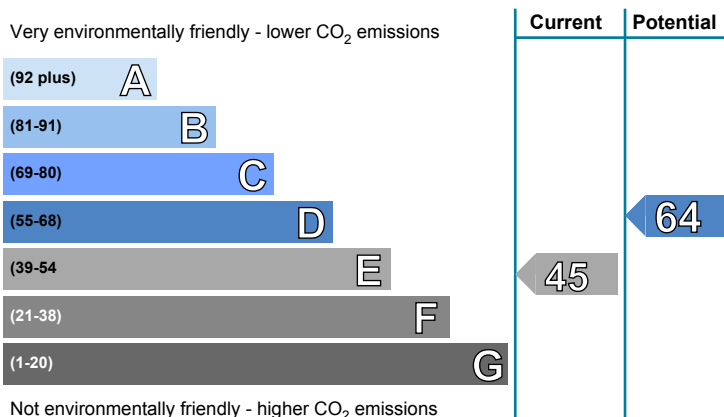
## Environmental Impact (CO<sub>2</sub>) Rating

This graph shows the effect of your home on the environment in terms of carbon dioxide (CO<sub>2</sub>) emissions. The higher the rating, the less impact it has on the environment.
